# XU 10 J4R ENGINE (RFV)

(1998cc 16 Valve)

MAN 158931

## EVOLUTION : XU10J4R ENGINE (RFV)

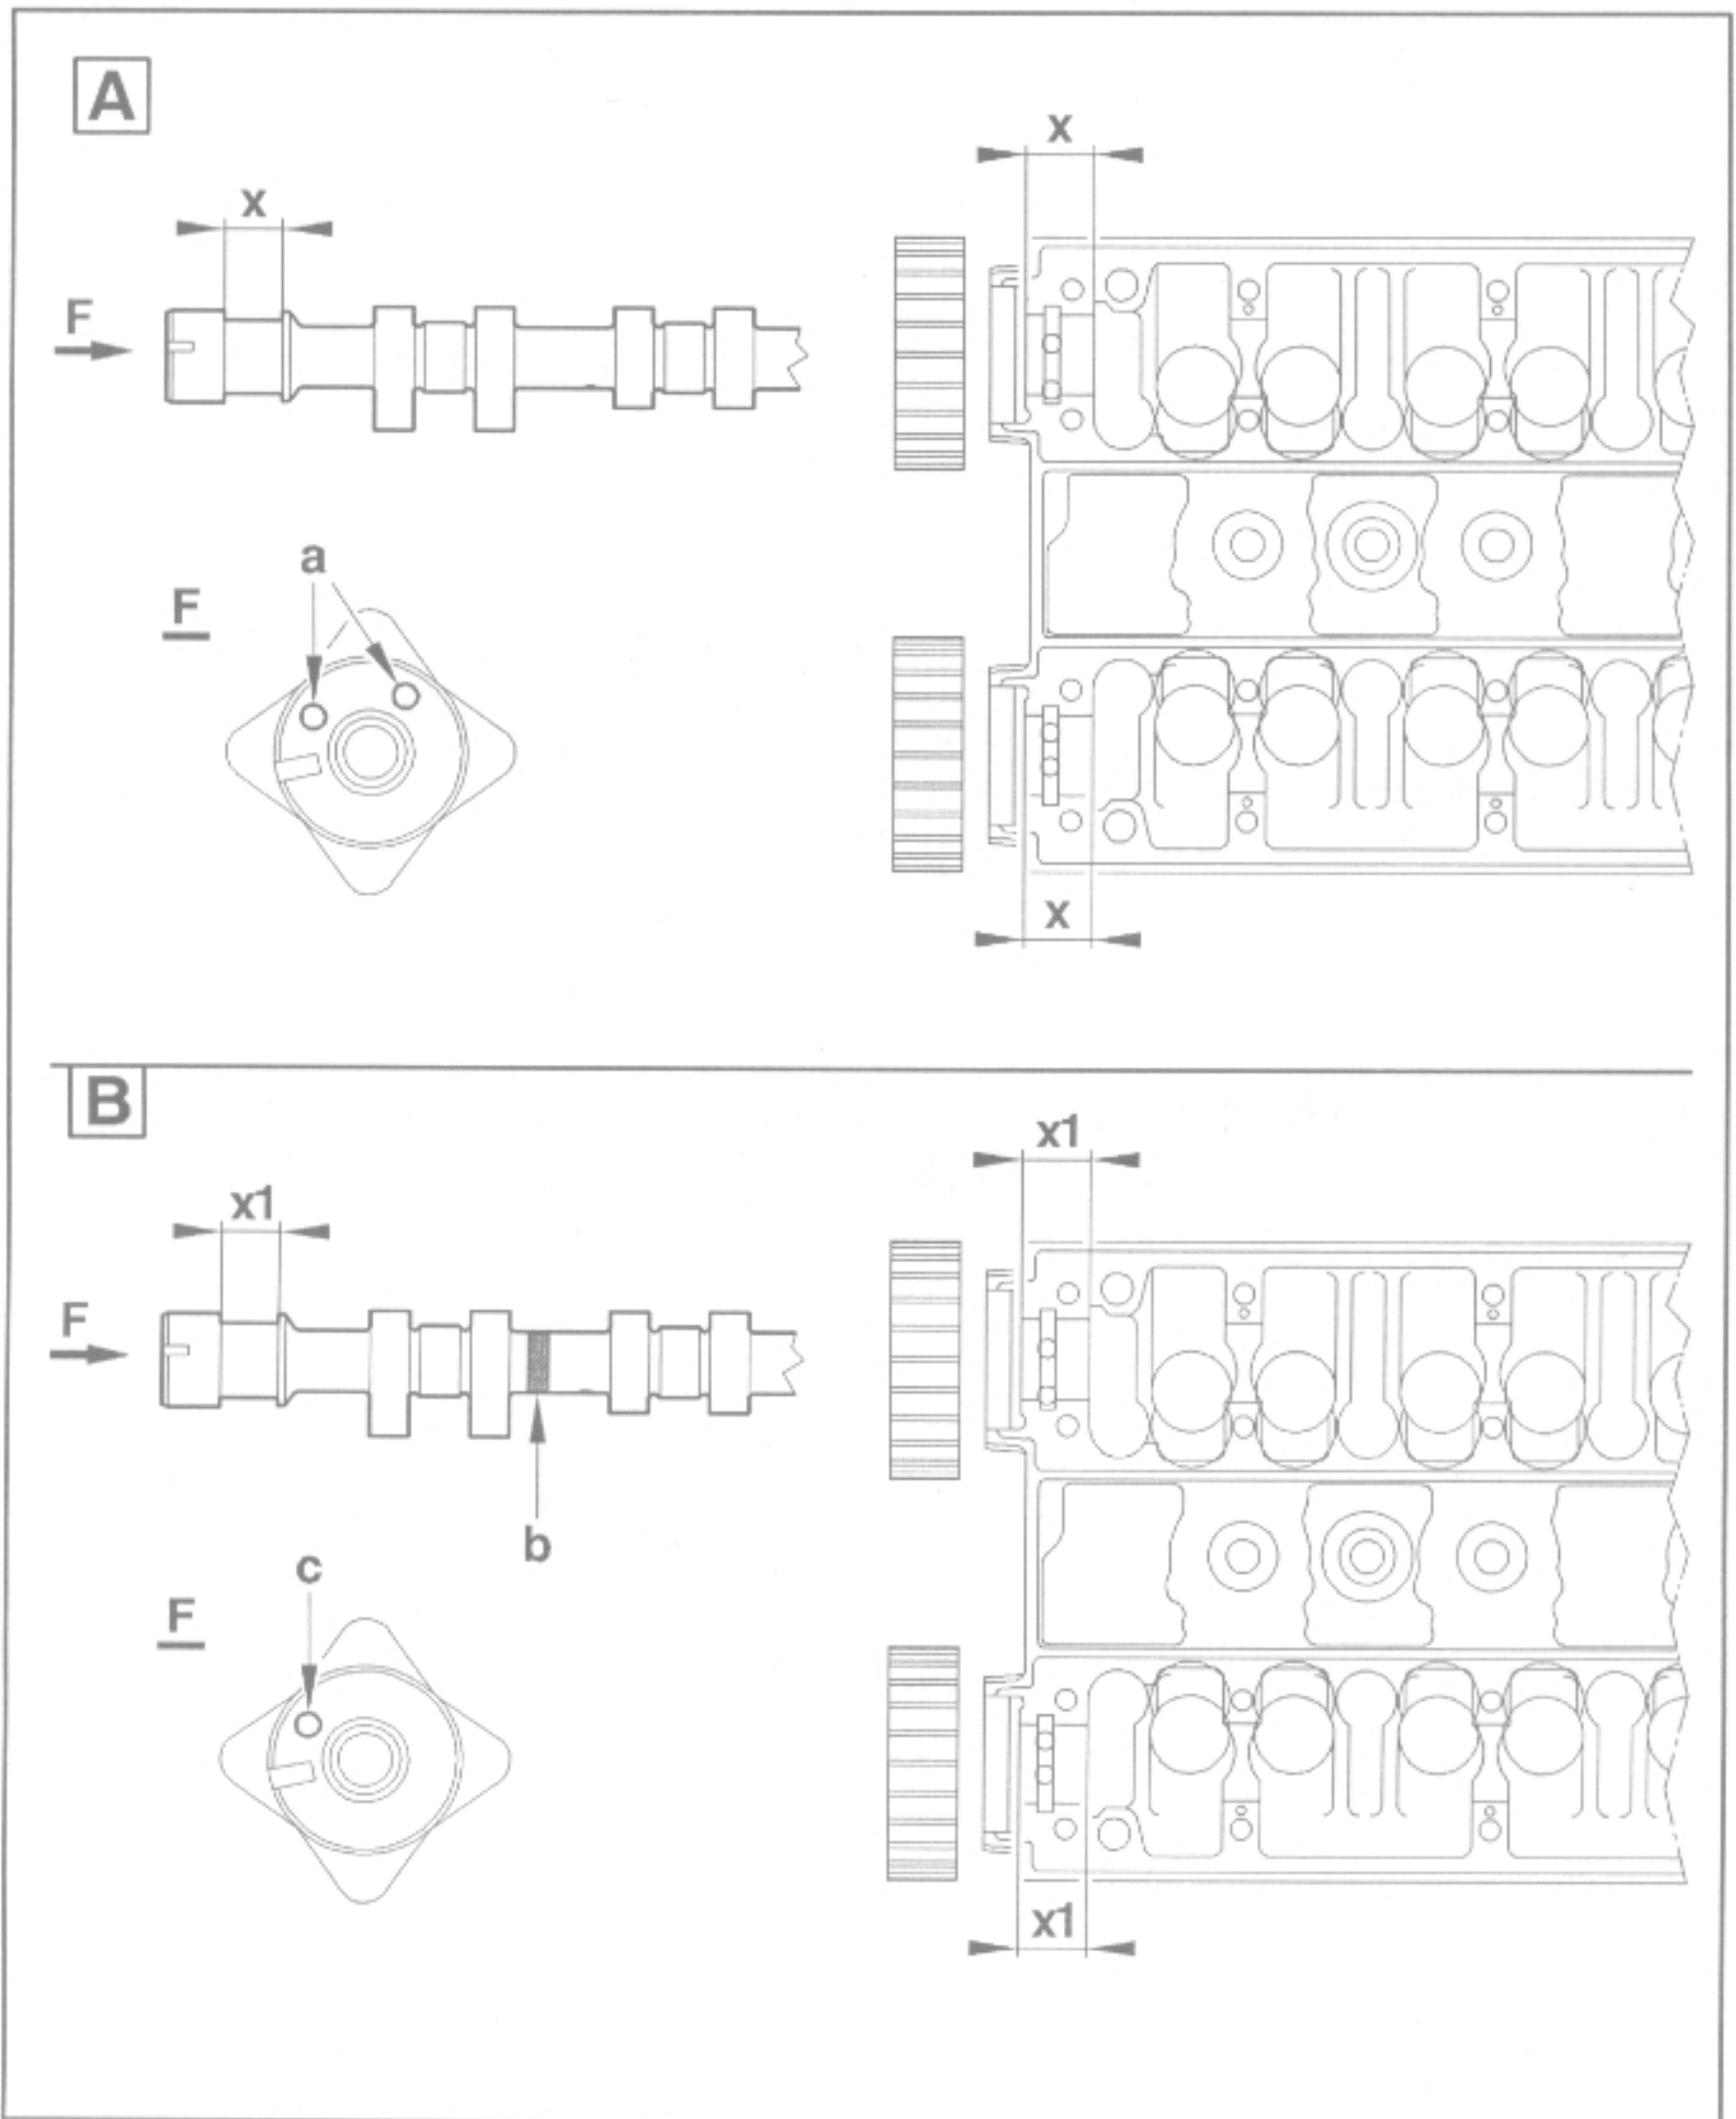
Fig : B1BP10YP

Reduction of width of the camshaft lateral bearing (bearing no. 5, gear side) : 23 mm instead of 24 mm.

Identification of the cylinder head : width of X = 23 mm.

The camshafts : width of X = 23 mm.

Identification of camshafts : 2 holes "a" on valve timing side (view F).

Identification of the cylinder head :  
width of X1 = 24 mm.

The camshafts : width of X1 = 24 mm.

- 1 white paint mark item "b"
- 1 hole "c" (depth 10 mm) on valve timing side (view F)

The parts of the earlier and later assemblies cannot be interchanged separately.

The early engines can be modified if all the new parts are fitted.

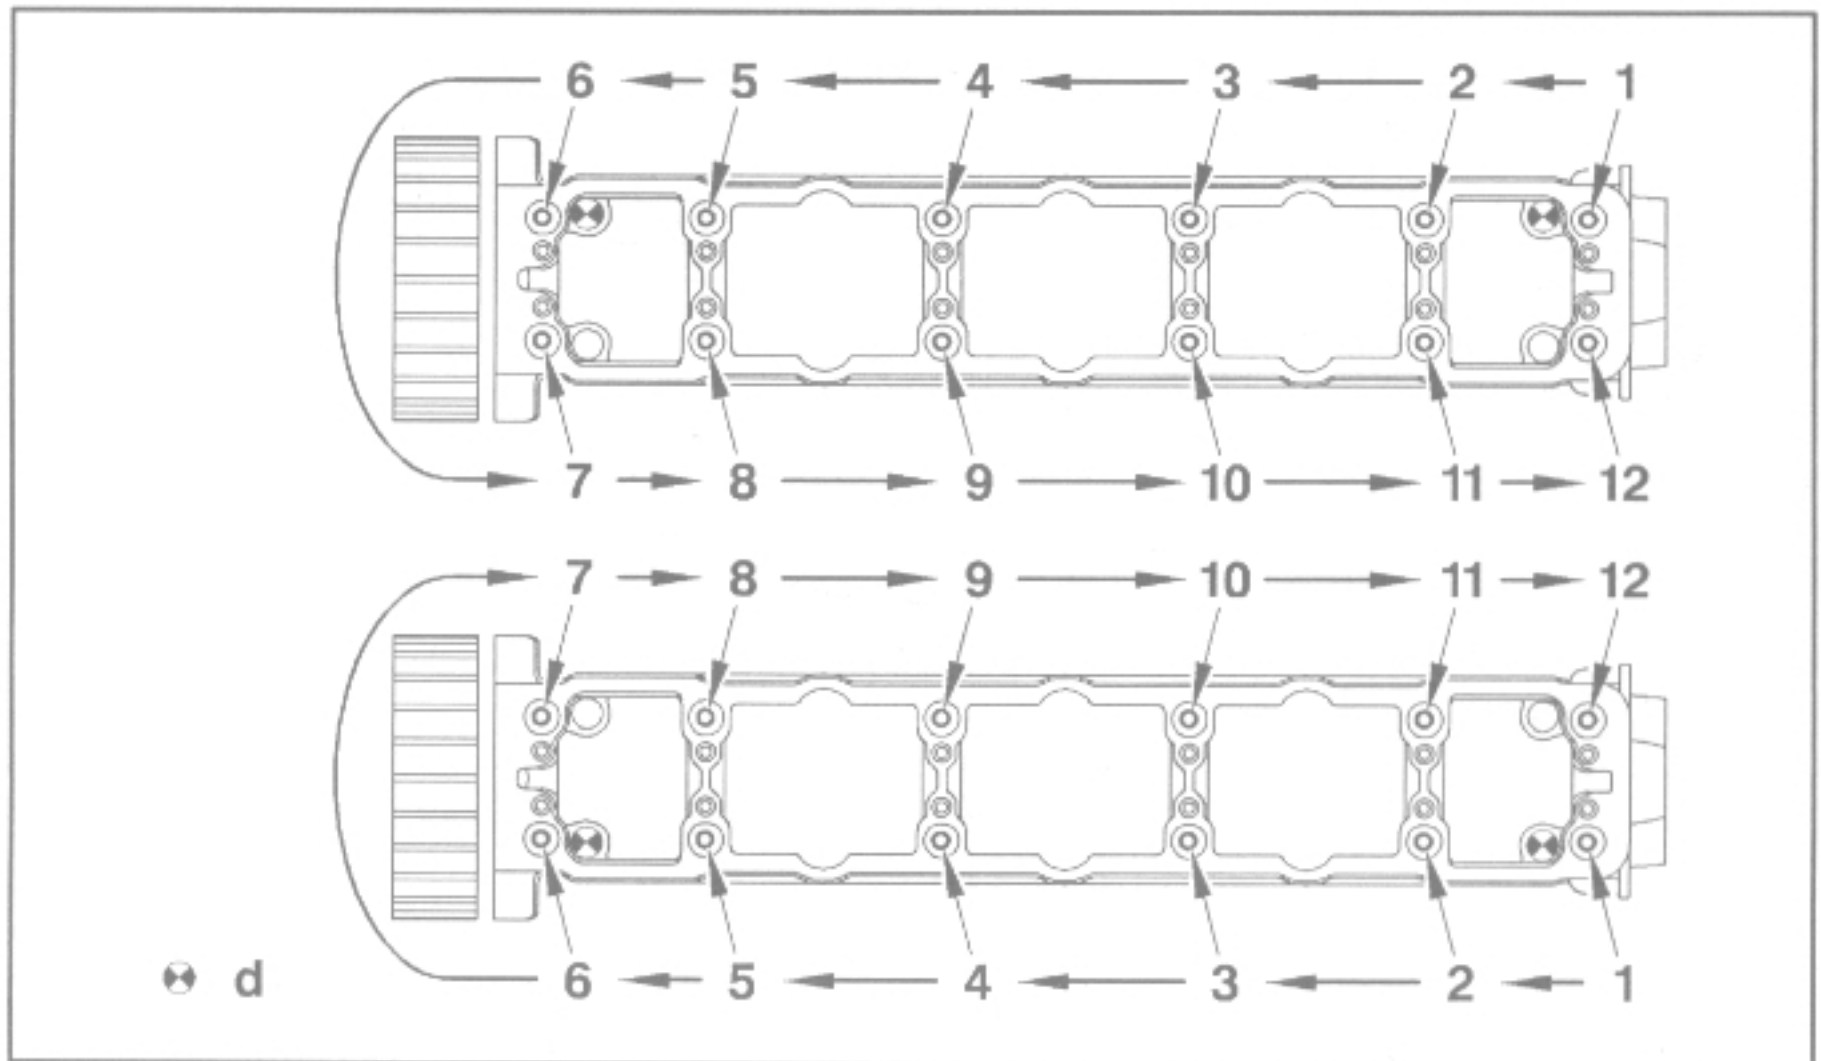
Fig : B1BP10ZD

New tightening method : "U" type tightening instead of "snail" type.

"d" locating peg on the cylinder head.

Tighten the retaining bolts in the order indicated.

- pre-tighten the screws to 0.5 m.daN
- tighten to 1 m.daN

**IMPERATIVE** : Only this new method should be applied.

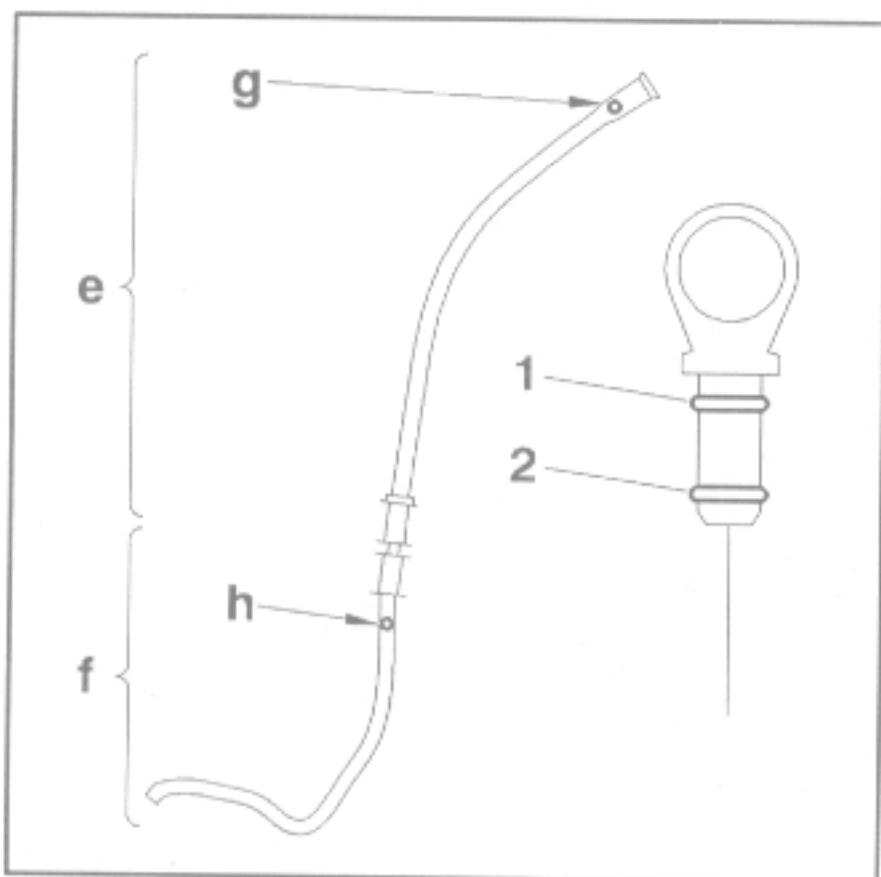
Fig : B1BP110C

The venting hole has been relocated from position "g" to position "h".

- upper dipstick guide tube "e" (without venting hole at position "g")
- lower dipstick guide tube "f" (with venting hole at position "h")
- dipstick with O-ring (2)

- upper dipstick guide tube "e" (with venting hole at position "g")
- lower dipstick guide tube "f" (without venting hole at position "h")
- dipstick with O-rings (1) and (2)

Diameter of venting holes : 2 mm.

The dipstick guide tubes of both assemblies are not interchangeable.

The fitting of a dipstick with only one seal on former engines is prohibited.

The early engines can only be modified if all the new parts are fitted.

- the fitting of a new lower dipstick guide tube (new arrangement)
- the fitting of a new upper dipstick guide tube (new arrangement)

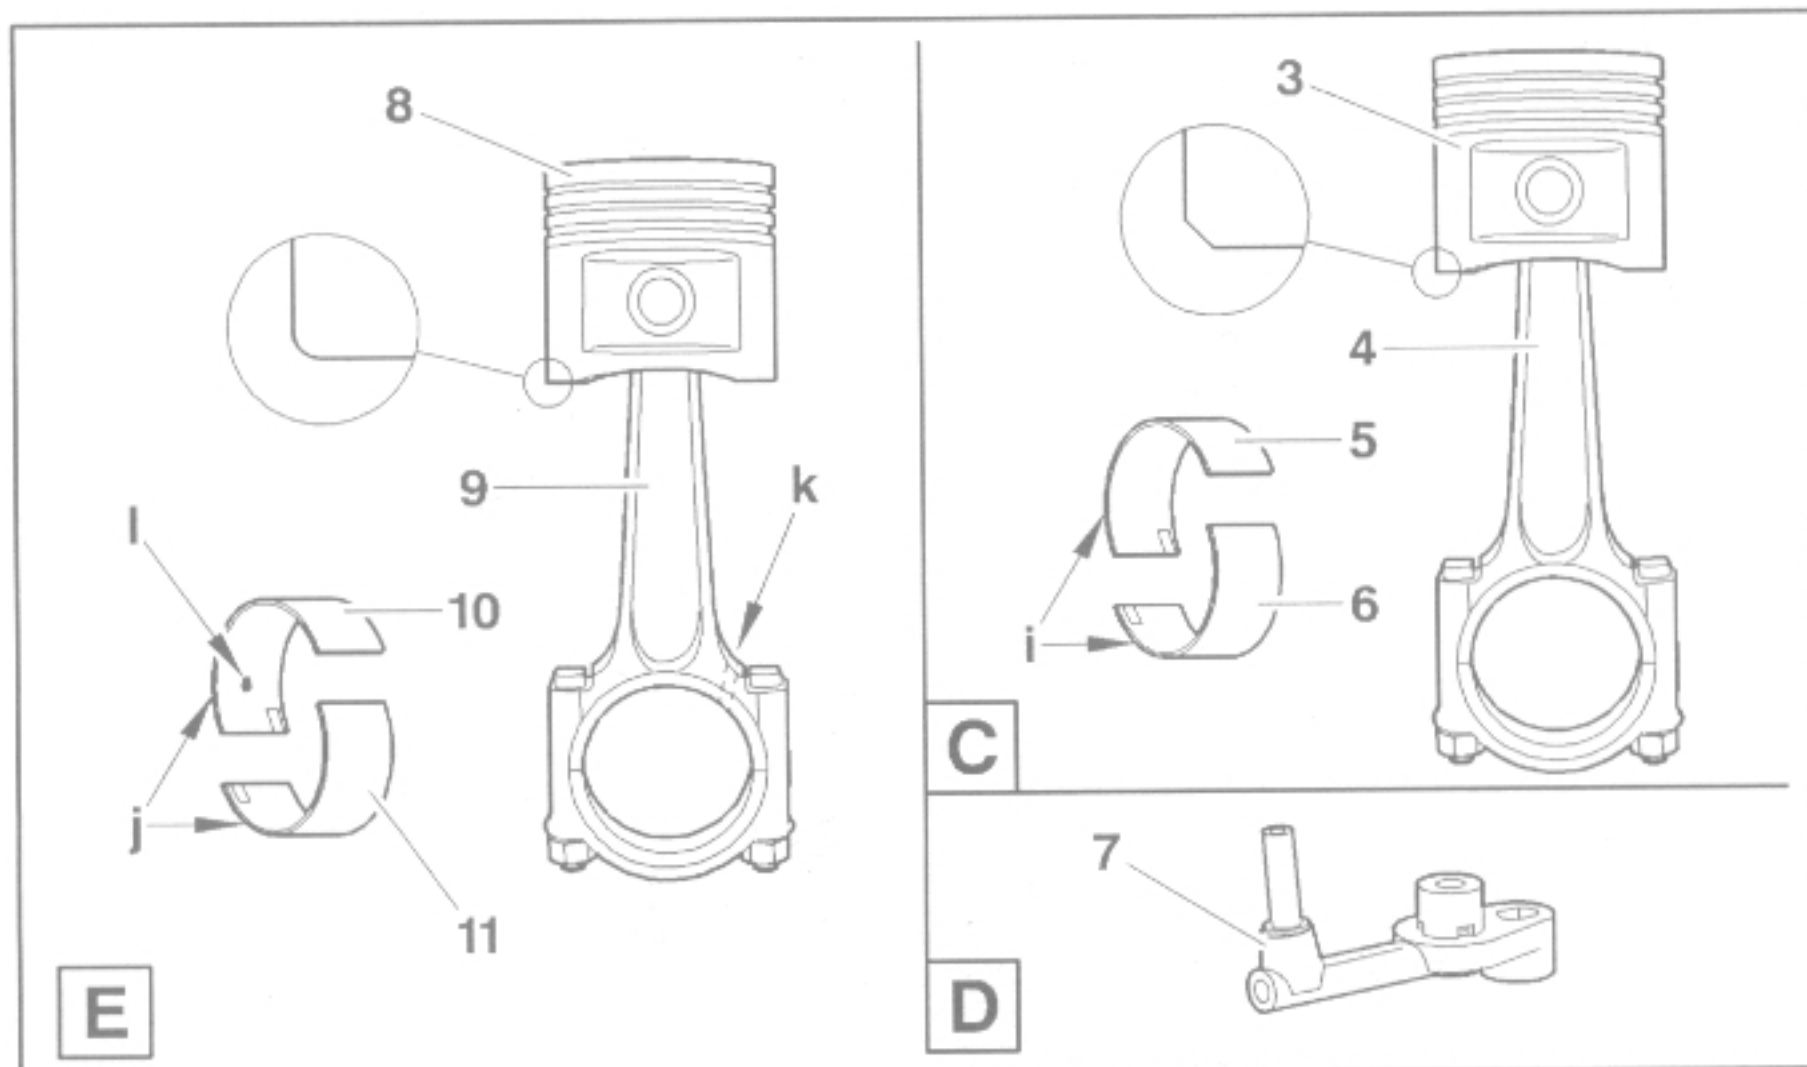
Fig : B1BP111D

Assembly N°1 : C.

Assembly N°2 : C + D.

Assembly N°3 : E.

- connecting rod, piston, connecting rod bearing halfshell assembly identical to assembly 1
- new cylinder block with nozzles to improve the lubrication of the liners

- new cylinder block (without nozzles), (improved surface condition of cylinders)
- the nozzles are replaced by a drilled connecting rod and upper bearing halfshell assembly
- new pistons, (improved surface condition of the skirt)

Parts	Connecting rod without drilling (4)	Connecting rod with drilling (9)
Former piston (3)	Yes	Yes
New piston (8)	No	Yes

The drilled connecting rod bearing halfshells can replace the bearing halfshells without drilling, but the reverse is prohibited.

Parts	Bearing halfshells without drilling (5 ; 6)	Drilled bearing halfshells (10 ; 11)
Connecting rod without drilling (4)	Yes	Yes
Connecting rod with drilling (9)	No	Yes

Parts	Cylinder block (assembly 1) (assembly 2)	Cylinder block (assembly 3)
Connecting rod without drilling (4)	Yes	No
Connecting rod with drilling (9)	Yes	Yes

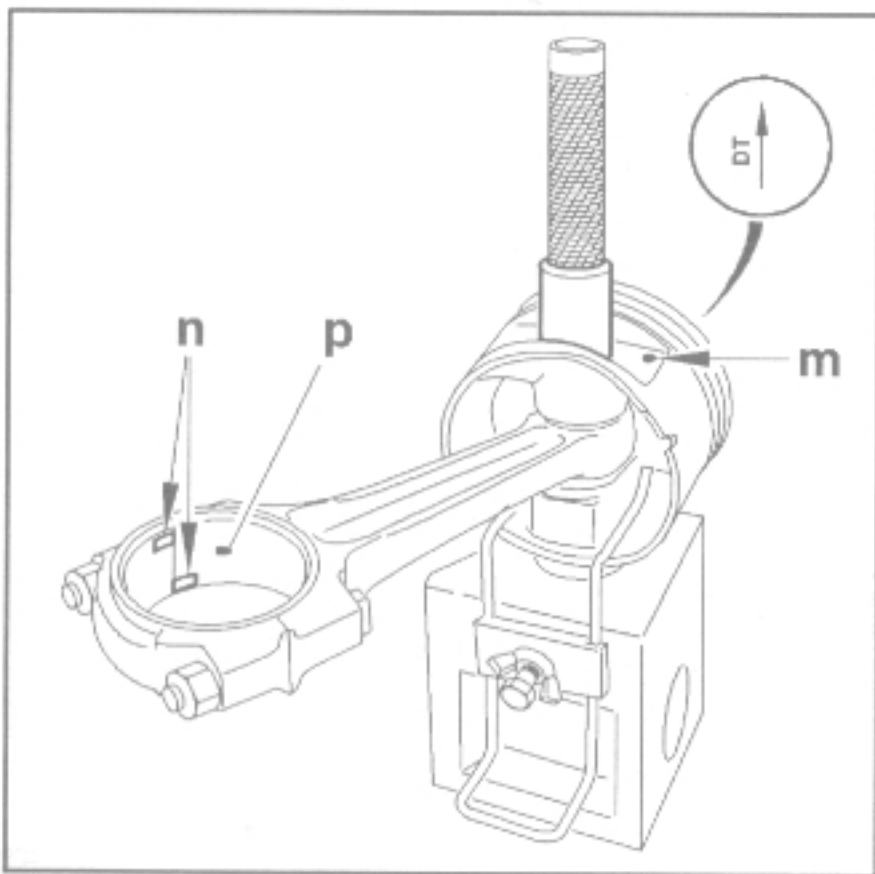
Fig : B1BP112C

- arrow "DT" positioned on the upper side
- casting spot "m" positioned on the upper side

Checking the correct positioning of the connecting rod : notches "n" on the left side.

**IMPERATIVE** : Observe the orientation of the connecting rod in relation to the piston.

- piston : arrow "DT" pointed towards the valve timing side
- connecting rod : hole "p" directed towards the exhaust side
